# Red Hook Water Storage Tank Engineering Report

Town of Red Hook Water District No. 1

August 24, 2022

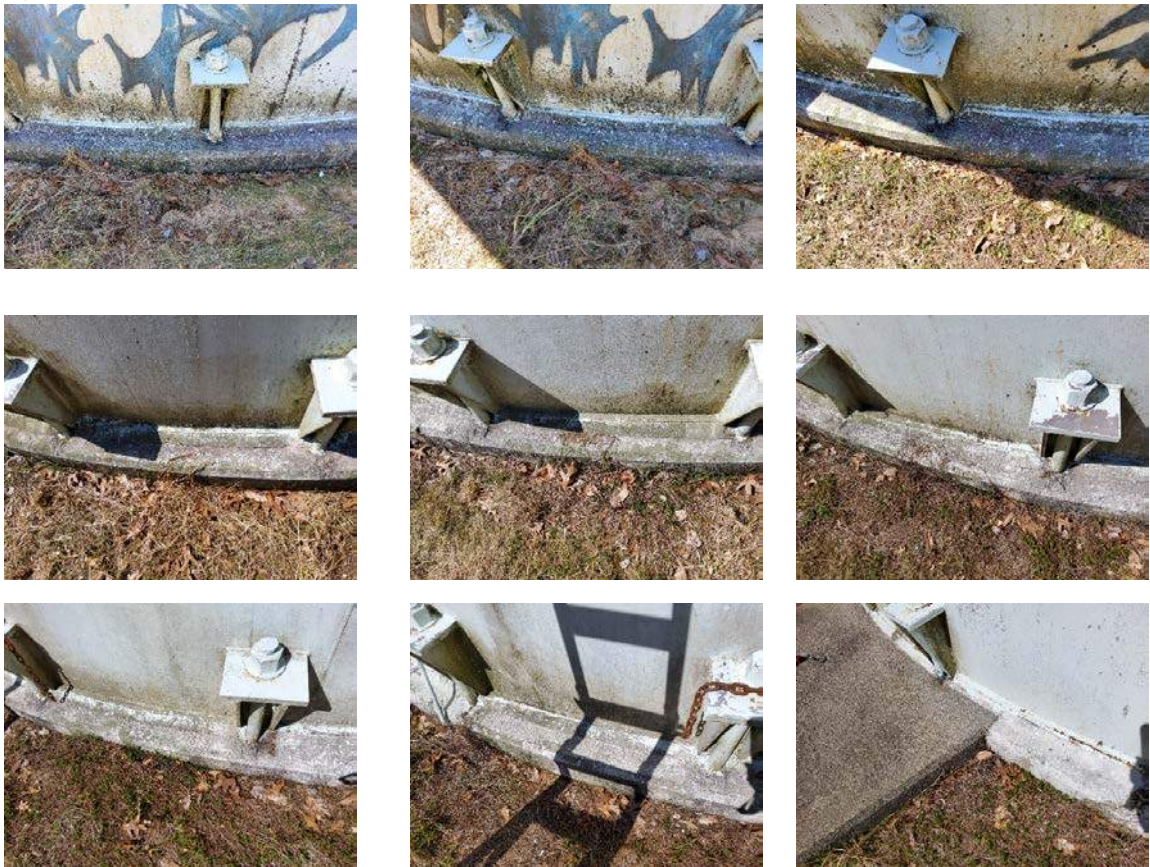
Exposed Foundation Photos

EXPOSED FOUNDATION	
Does this structure have an exposed foundation?	Yes
What is the height of this foundation? (In Inches)	8
What is the width of this foundation? (In Inches)	12
What is the condition of the concrete?	Concrete base slab was found to be in good condition at this time. Concrete was found to be coated with approximately 50% of all surfaces having coating failure. Less than 5% of all surfaces has shrinkage cracks with no substantial depth or width at thus time.
